# SiRF Application Notes

## Troubleshooting Note for SiRFstar III Board Development

Document Number **APNT3003**

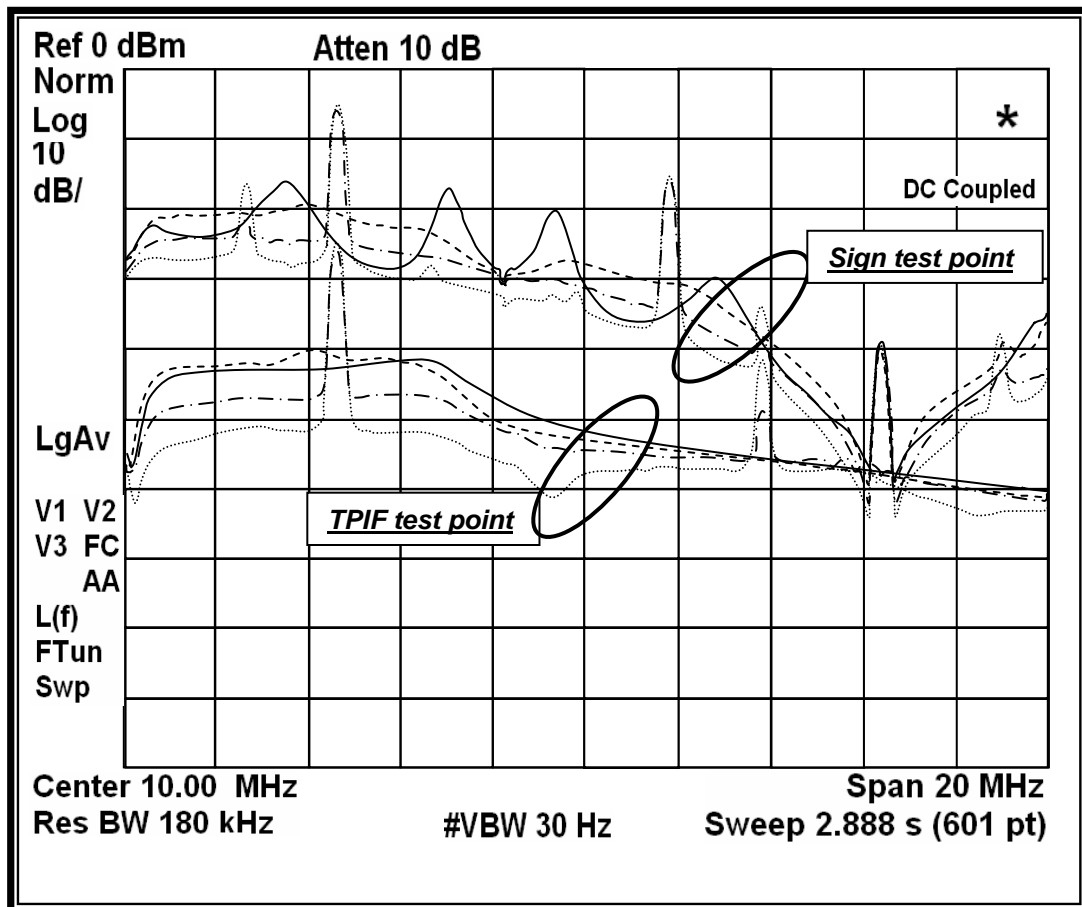
Fig 2

For spectrum analyzer set up follow the settings as listed in Figure 2 for, ref level, center freq., span, etc., measure the output of both the sign and TPIF pins and compare with the plots as listed below. The top waveforms are for the sign measurement and the lower waveforms are for the TPIF measurement. The lines displayed in Figure 3 represent the various conditions for evaluating jamming concerns. With the antenna input of the receiver terminated, the waveforms should be as illustrated. If internal jamming is present spikes or peaks should be evident. With an antenna connected and no jamming present, the waveform should be similar to the “dashed” line with no peaks or spikes. If peaks or spikes are present then most likely jamming is entering through this path.

The main purpose of this software is to activate TP\_IF pin #31 on the GRF3w RF device. Under normal operating conditions with standard SSIII software the TP\_IF pin is not activated in order to reduce current consumption. Once activated post-mixer IF measurements can be made using a wideband FET probe (BW>500MHz) into a spectrum analyzer. Figure 2 is an illustration of such measurements under terminated, no jamming, and simulated in-band jamming conditions.
